Home Inspection Report

Parker & Company Home Inspection

Sample Report Way

Date of Inspection: 3/30/2021

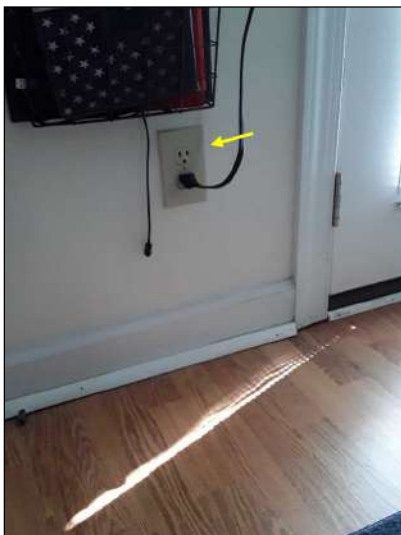
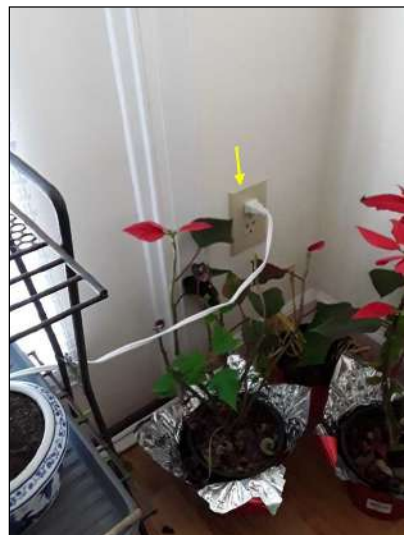
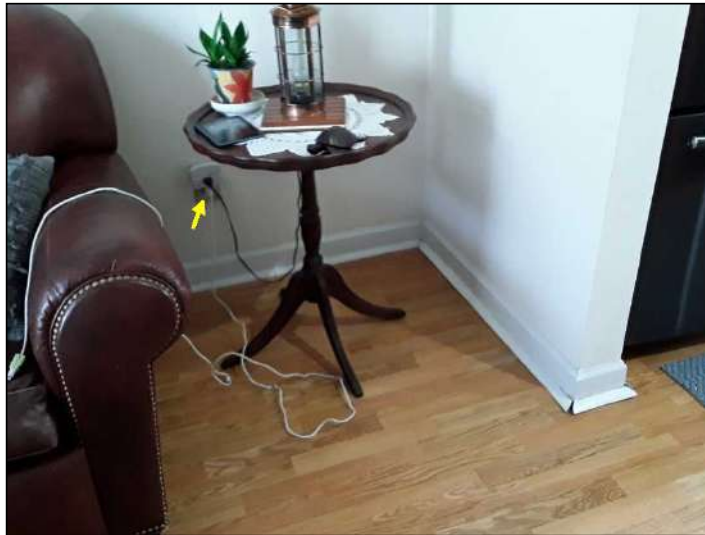
4. Electrical

- Some outlets not accessible due to furniture and or stored personal items.
- Appeared functional at the time of inspection.
- Several receptacles are loose at the time of inspection. It is recommended to have these receptacles properly installed to prevent any wiring from coming loose from their connections.

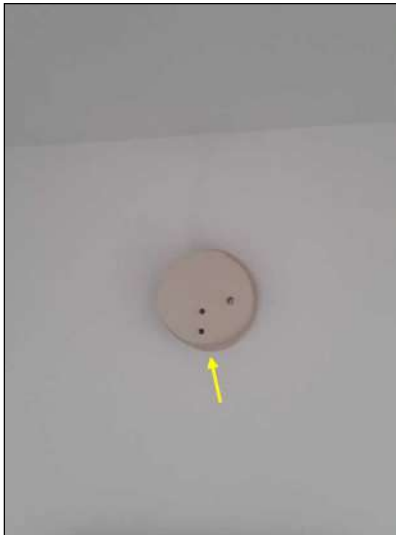
5. Smoke Detectors

- Upstairs hallway smoke detector is old. Smoke detectors last 6-10 years. When smoke detectors turn yellow or off white, that is an indicator that it needs replacement.

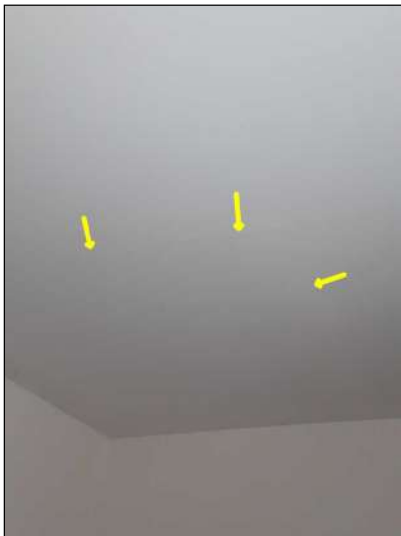
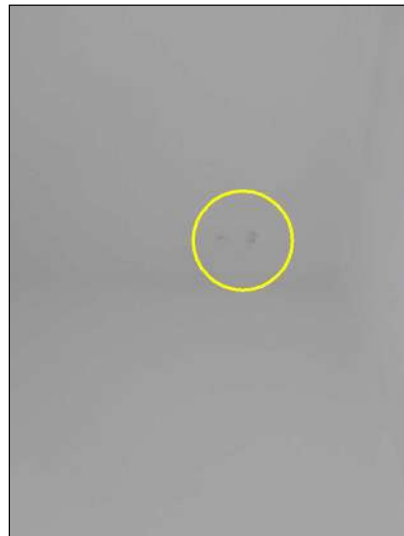
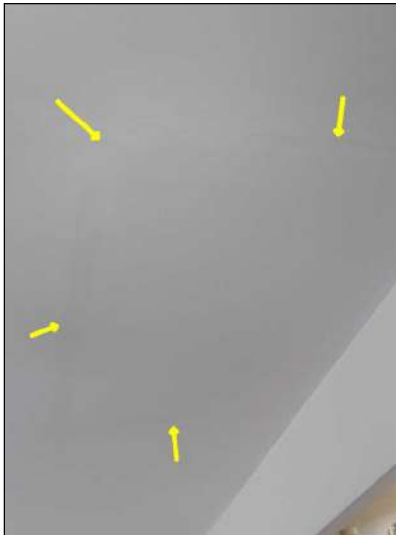
7. Ceiling Condition

- Observations:
- The drywall is patched in areas. The reason for the patch could not be determined but is assumed that it is due to old drywall tape.

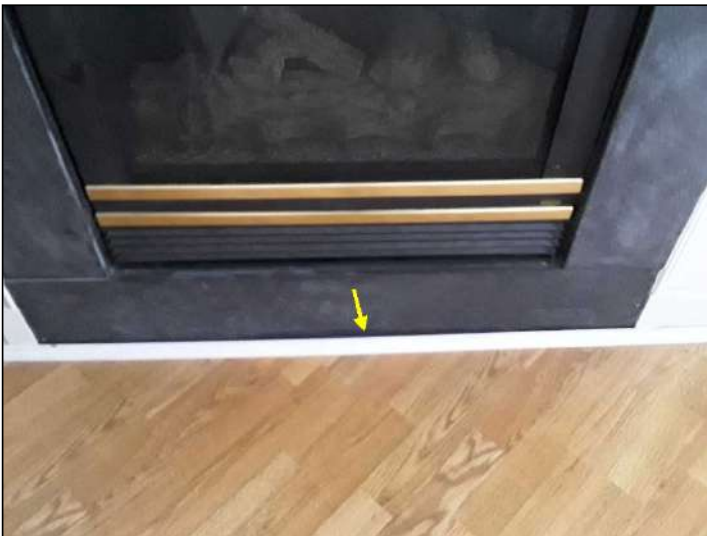
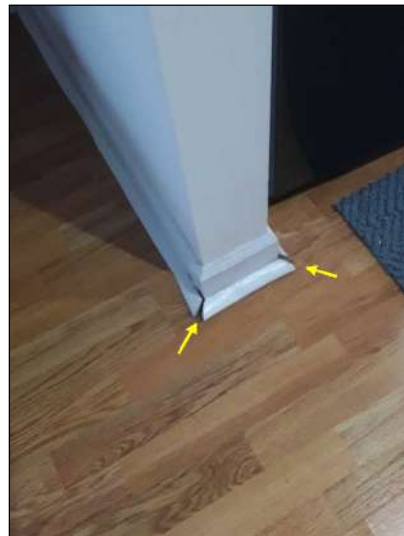
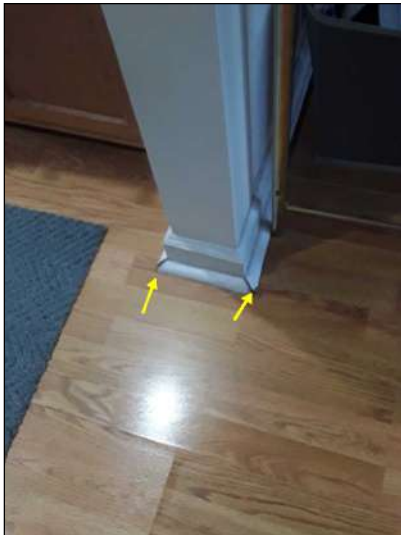
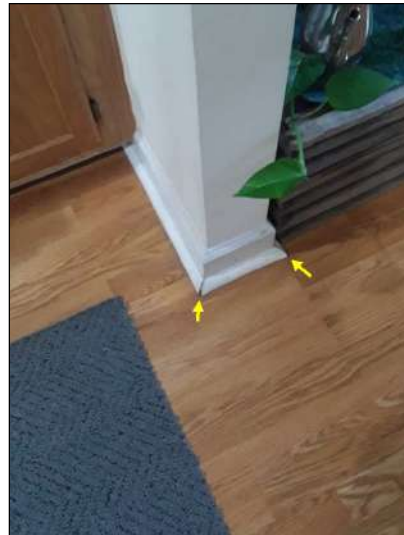
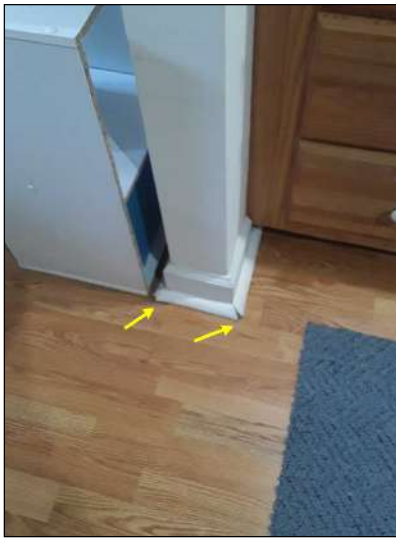
9. Wall Condition

- Some areas not accessible due to stored personal items.
- Appeared functional at the time of inspection.
- Several locations in which the lower trim is noted to be loose or damaged.

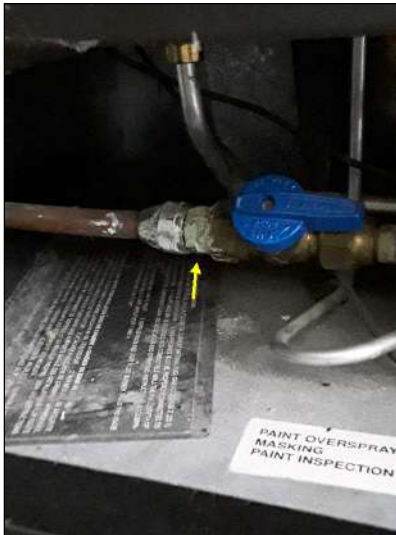
10. Fireplace

- Have a gas fireplace professional service/evaluate fireplace before operating.
- What appears to be possible corrosion due to two dissimilar metals are joined together. Creating what is known as electrolysis. Recommend having a gas fire place professional service fire place prior to operation.
- Gas service to fireplace shut off at the time of inspection.

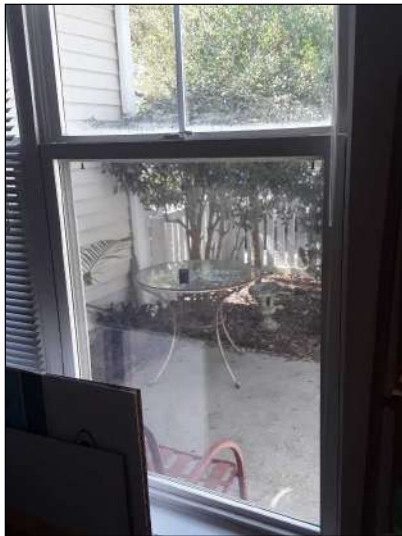
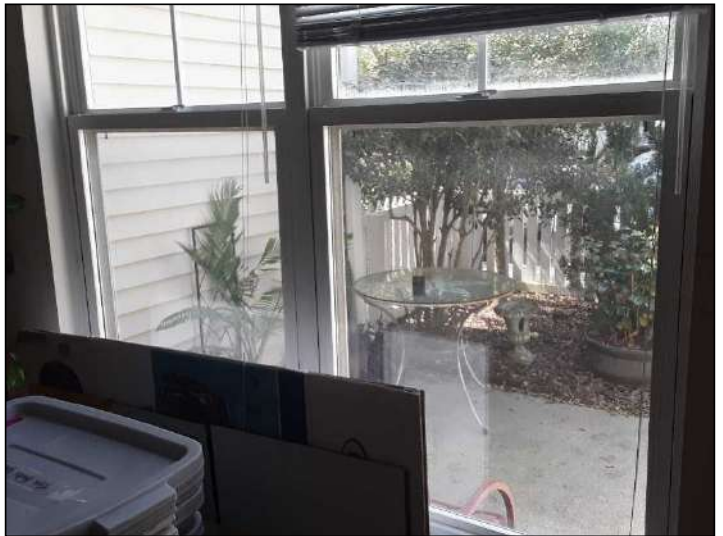
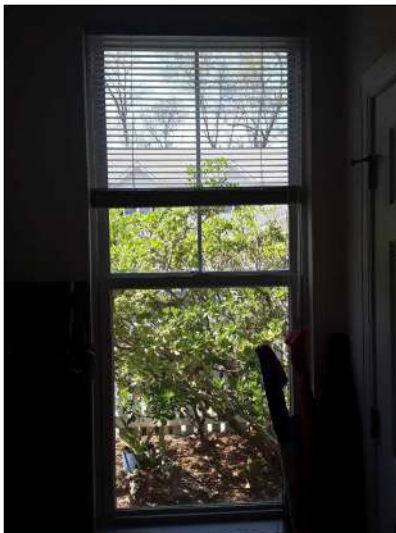
11. Window Condition

- Windows located downstairs were unable to stay open at the time of inspection. It is recommended to repair/replace by a professional window company.

Interior Areas		
Page 9 Item: 11	Window Condition	<ul style="list-style-type: none"> • Windows located downstairs were unable to stay open at the time of inspection. It is recommended to repair/replace by a professional window company.
Bedrooms		
Page 10 Item: 6	Smoke Detectors	<ul style="list-style-type: none"> • There were no smoke detectors present in the bedroom(s). It is recommended to have a smoke detector and CO detector in each bedroom to bring the home up to modern safety standards. • No CO detector was observed at time of inspection.
Page 11 Item: 8	Window Condition	<ul style="list-style-type: none"> • The windows upstairs do not stay open on their own at the time of Inspection. It is recommended to have all windows evaluated and repair/replace by a professional window company.

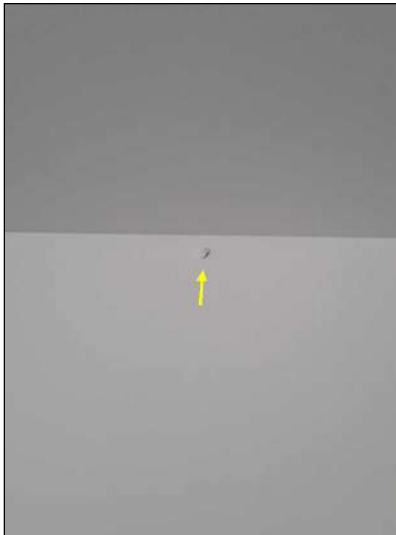
7. Wall Condition

- Some areas not accessible due to stored personal items.
- Appeared functional at the time of inspection.
- Dry wall nail pop noted In guest bedroom.

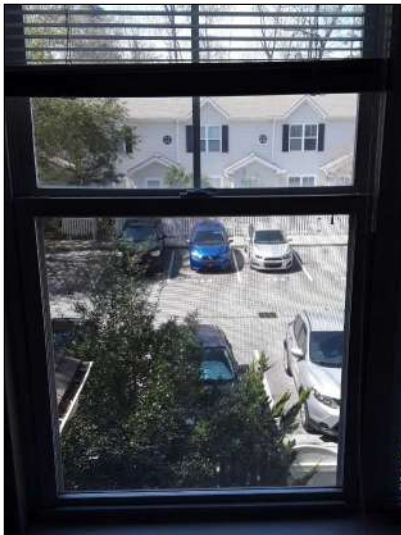
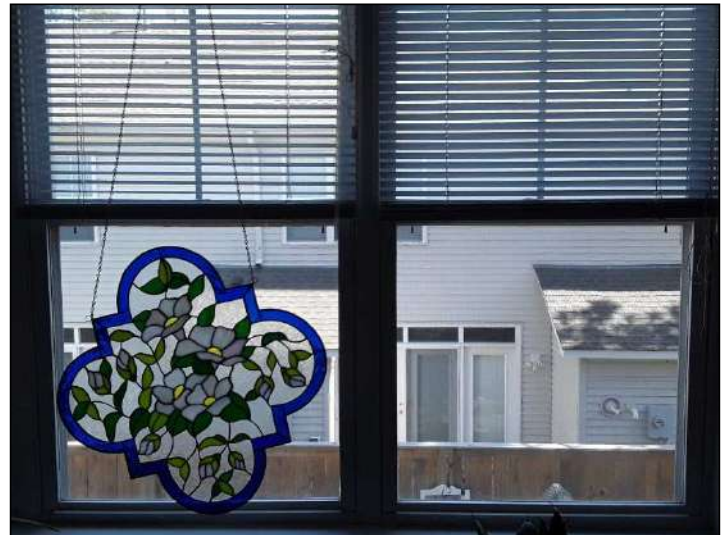
8. Window Condition

- The windows upstairs do not stay open on their own at the time of inspection. It is recommended to have all windows evaluated and repair/replace by a professional window company.

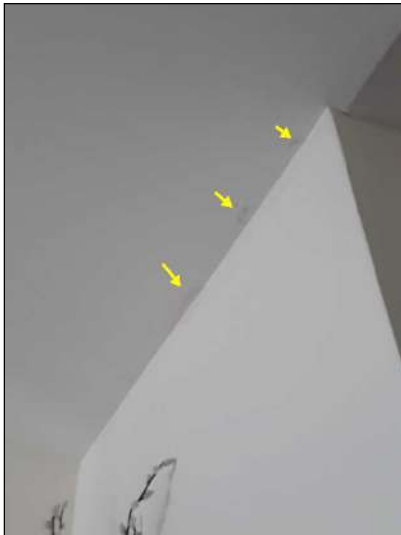
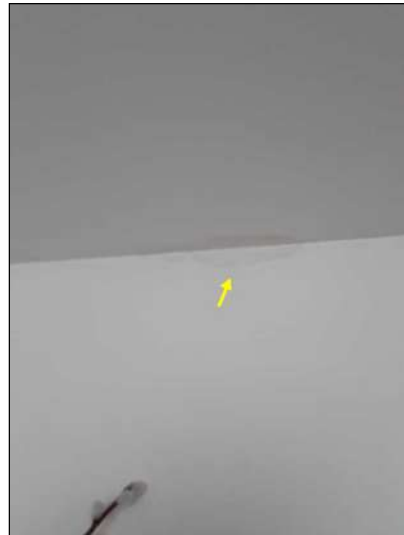
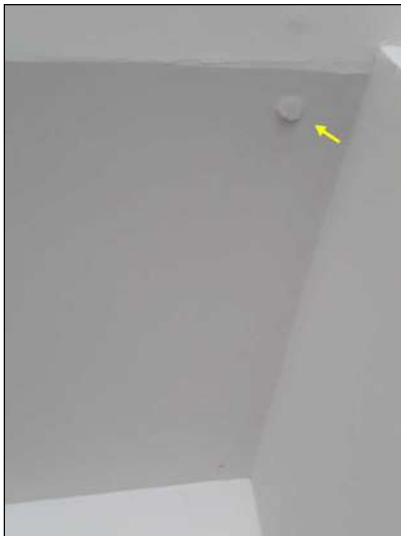
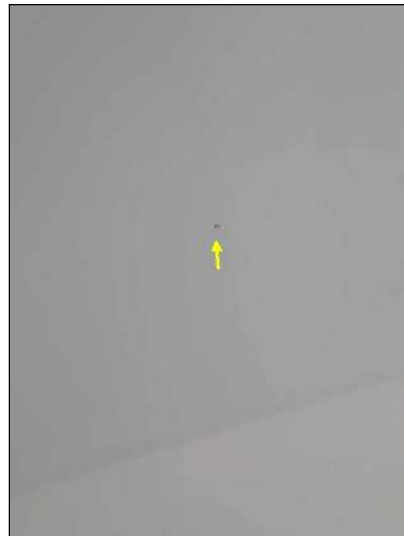
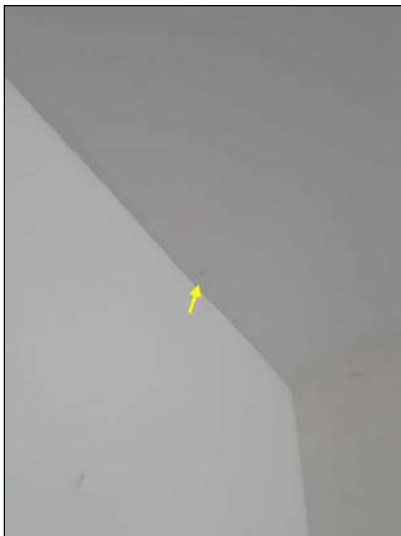
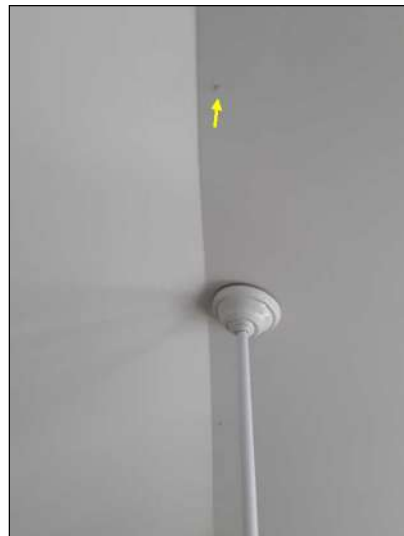
9. Ceiling Condition

- Small stains noted on the master bedroom ceiling. They tested dry at the time of the inspection.
- Appeared functional at the time of inspection.
- Dry wall nail pops noted in master bedroom.

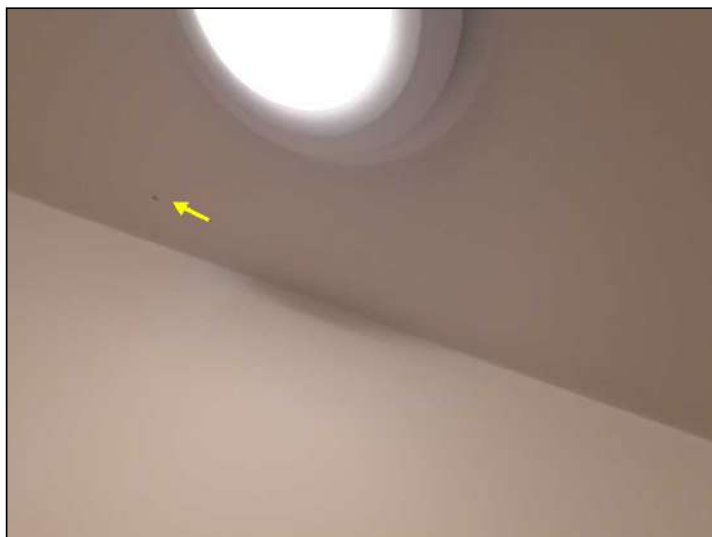
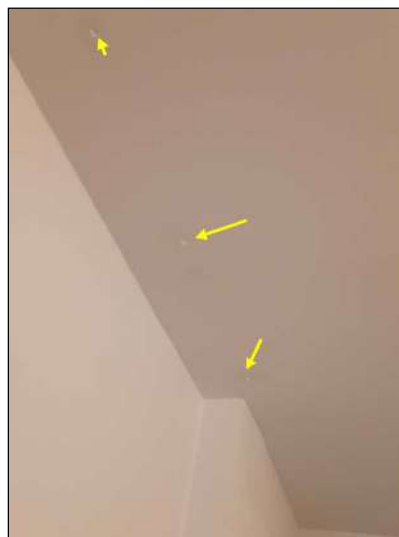
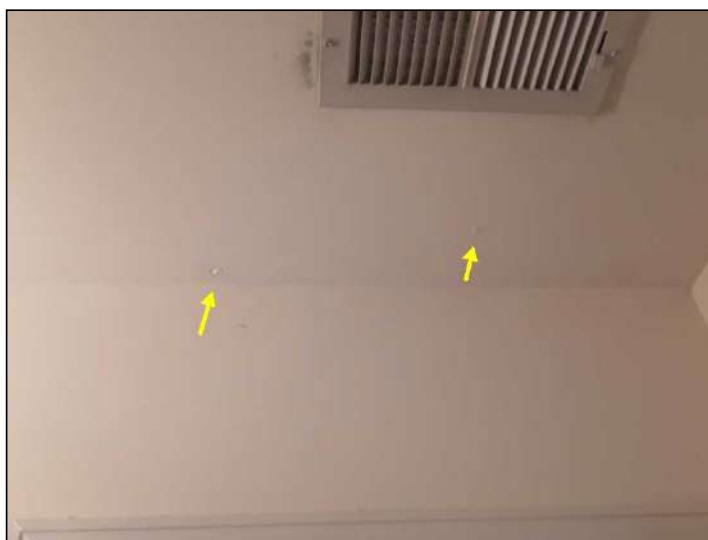
2. Ceiling Condition

- Appeared functional at the time of inspection.
- Drywall nail pops in guest bathroom.

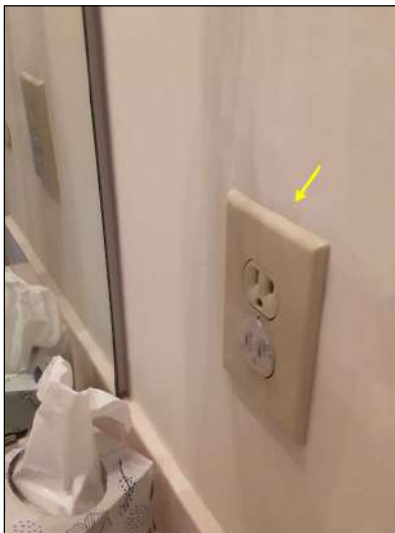
5. Electrical

- Some outlets were not accessible due to furniture and or stored personal items in the way.
- Appeared functional at the time of inspection.
- Loose receptacle noted in the guest bathroom. It is recommended to repair/replace by a licensed electrician.

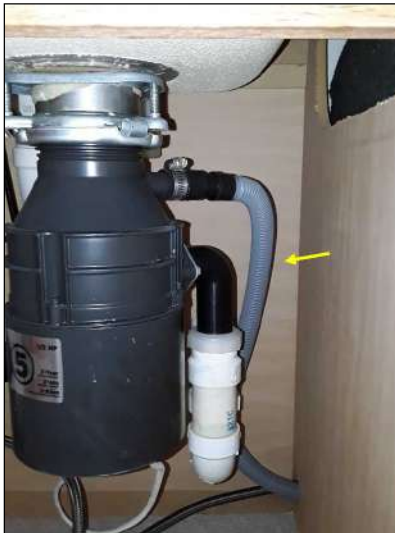
3. Dishwasher

- Operated when tested at the time of inspection.
- Lack of a proper **air gap** noted at dishwasher drain line. In the event of a sewer backup this device prevents sewer matter from entering into dishwasher. Recommend having a qualified plumber install a air gap to prevent possible contamination.

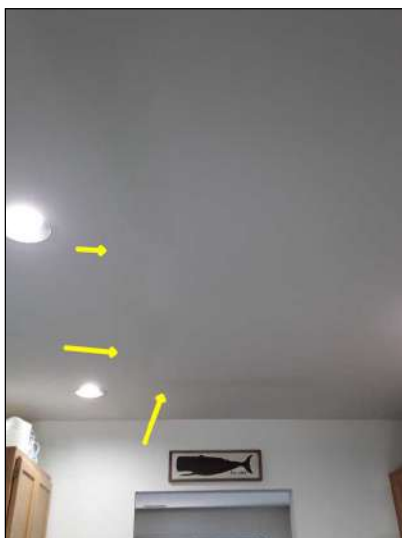
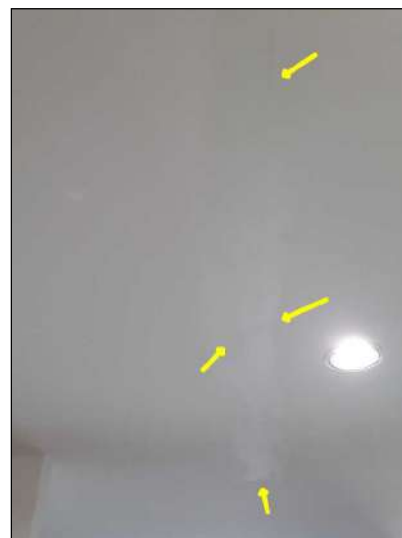
12. Ceiling Condition

- Small cracking in the wall finish is noted. This is probably caused by the joint compound (spackle) drying too quickly during application.

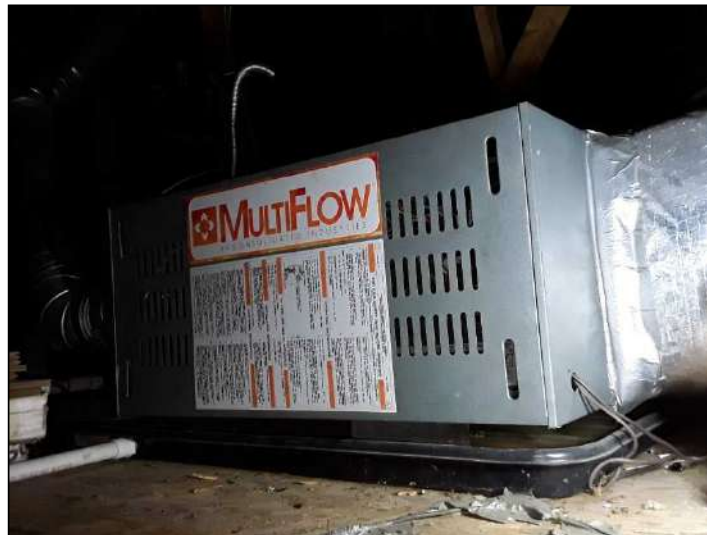
1. Furnace/Heater Condition

- Fuel Furnace: Last service date is over one year ago, or is unable to be determined. Although this unit appears to be operating properly from controls, there are areas which cannot be seen without specialized equipment and training. One such area is the combustion chamber / heat exchanger where cold air blows across the "fire box", becoming the hot air that circulates throughout your home. During the life span of any furnace, this metal wall may develop a crack or a broken weld, allowing carbon monoxide to circulate throughout the home. This is why furnace specialists recommend a complete inspection annually; consider having unit inspected by certified HVAC technician.

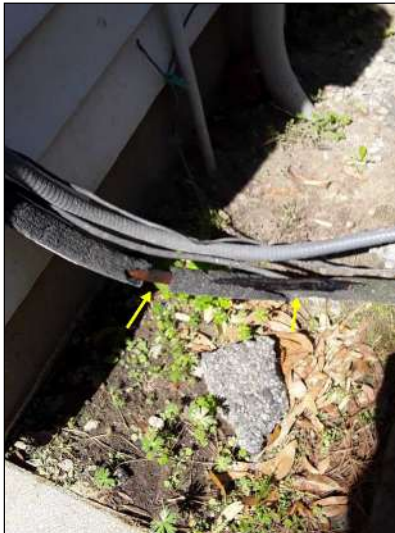
6. Refrigerant Lines

- Recommend replacing insulation along refrigerant line to ensure energy efficiency is not lost.

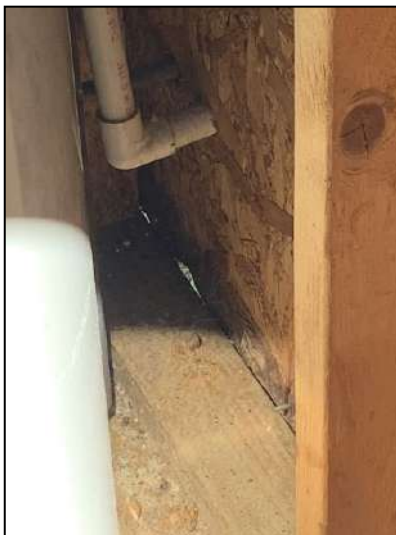
1. Base

- The water heater base is functional.
- Daylight observed behind the water heater in the exterior storage closet. It is recommended to seal all gaps/holes.

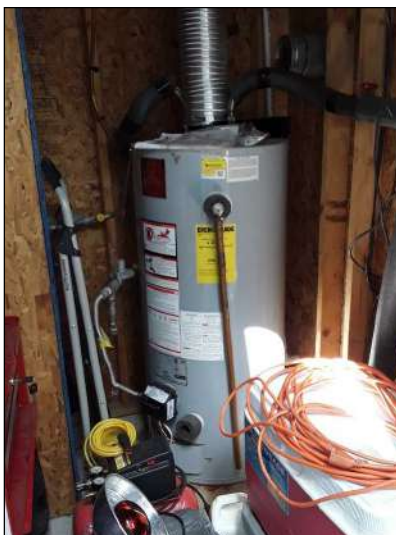
5. Water Heater Condition

- Water Source: Public
 - Make: State Select
- Model Number: GS640YBDS 290
Serial Number: 1426A014498
Age of unit: 2014

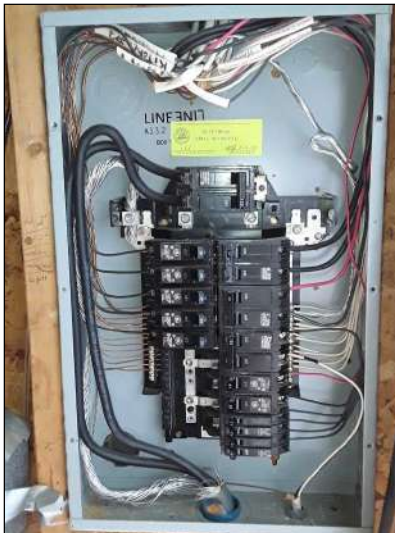
1. Electrical Panel

- No major system safety or function concerns noted at time of inspection at main panel box.

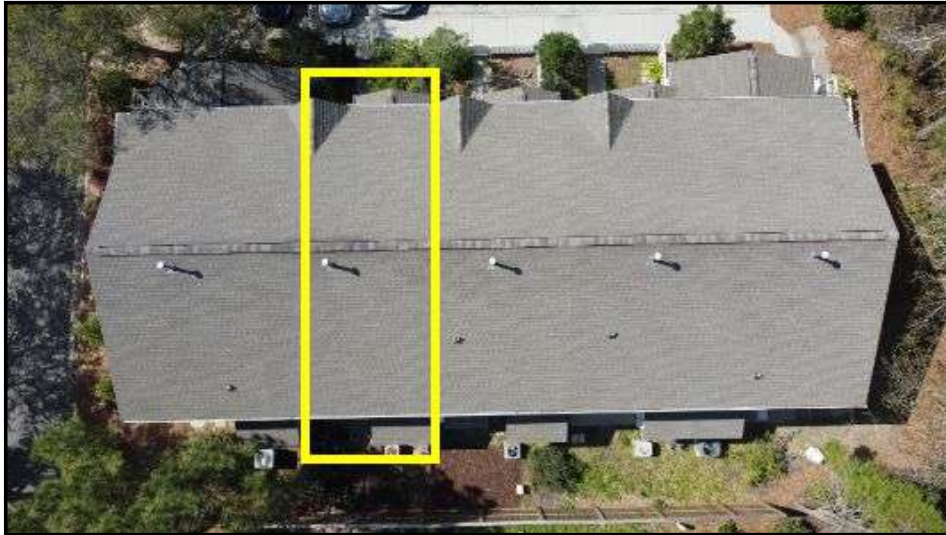
1. Roof Condition

- Materials: Observed by use of a Drone.
Materials: Asphalt shingles noted.
Observations:
- nail pop noted at the time of inspection.

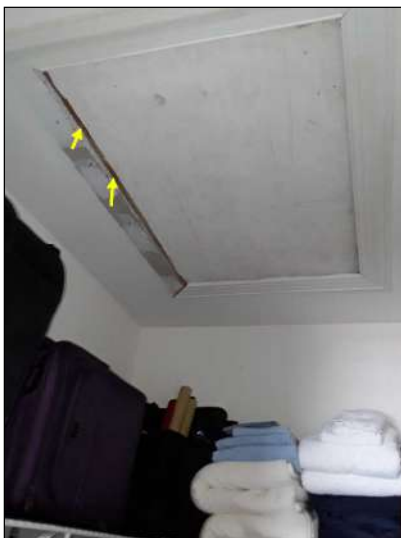
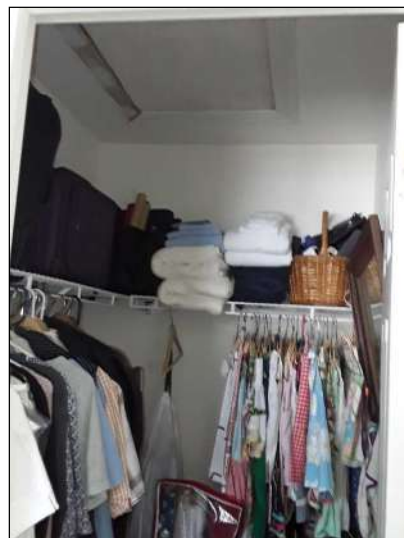
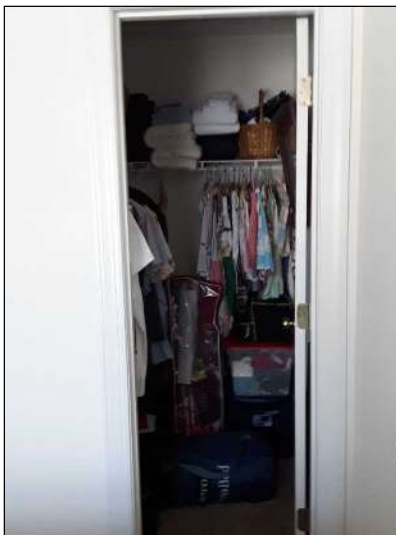
- Scuttle Hole located in: guest bedroom closet
- Access was limited due to personal property in the way.
- Access missing one side of framing. Recommend repair/replace by a contractor to ensure the hatch remains in place.

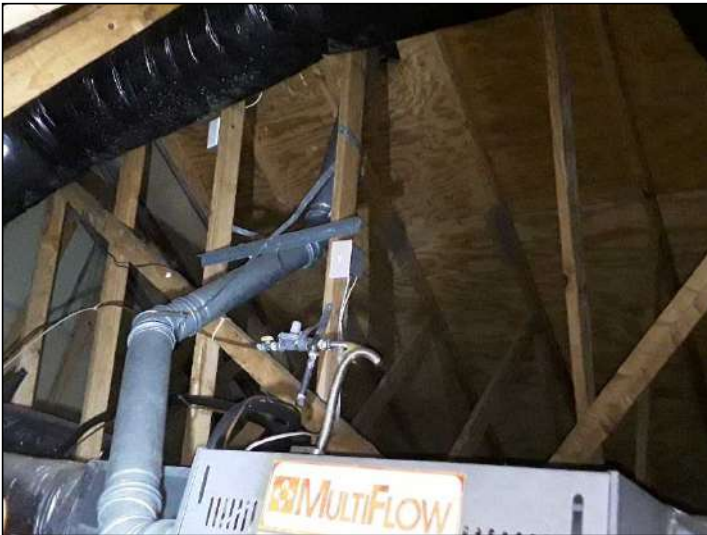
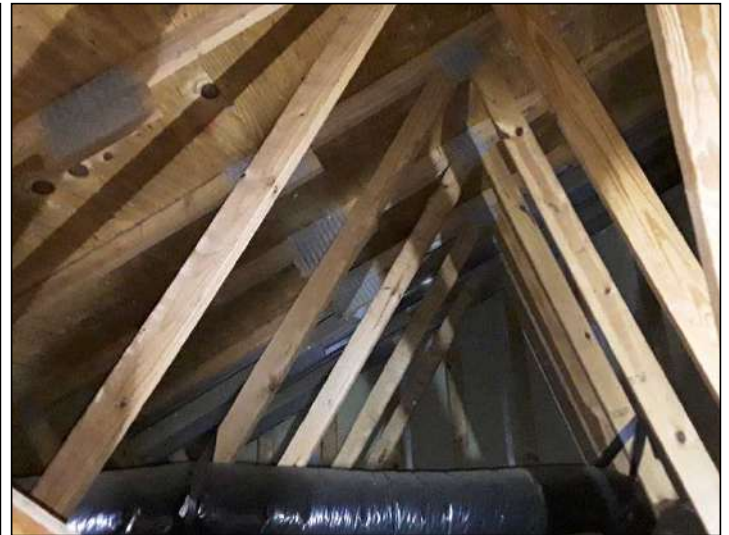
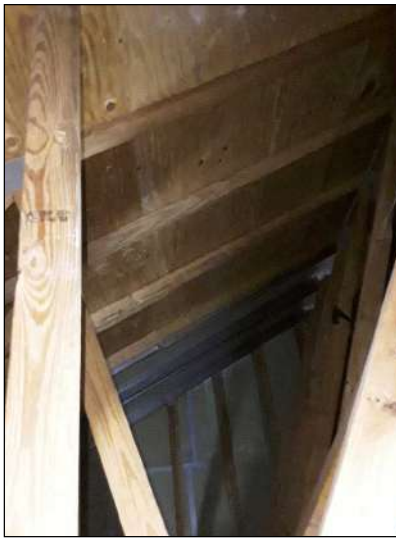
2. Structure

- No major system safety or function concerns noted at the time of inspection.
- Attic structure observed from scuttle hole due to limited access.

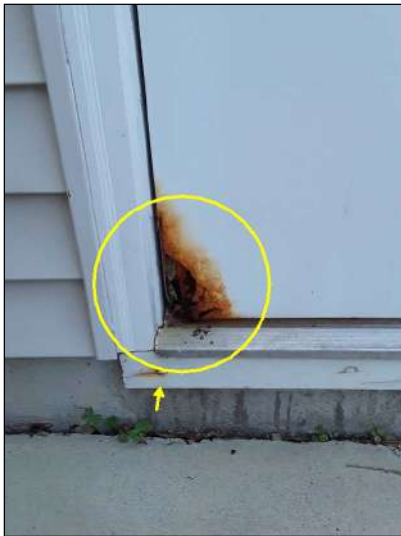
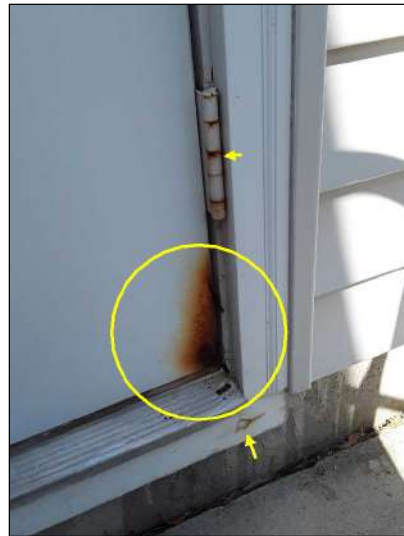
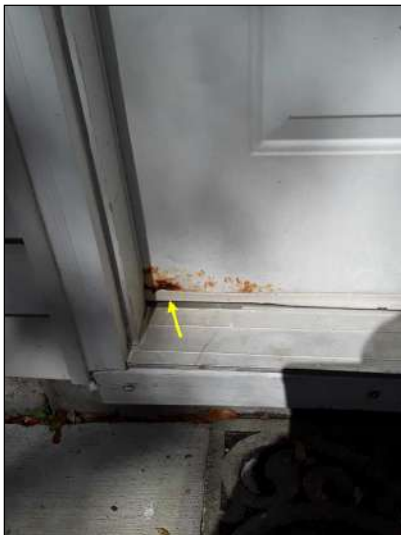
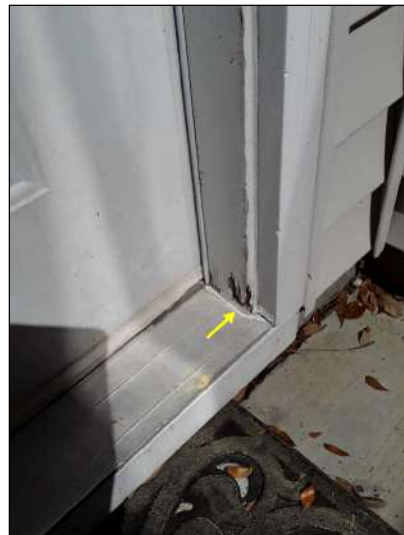
- Front door as well as the exterior closet door showing signs of rust. It is recommended to repair/replace by a professional.
- Functioned as intended.
